INSPECTION PROGRAM H 36 DIMONA  
3000 hour inspection  
and extension of life time to 6000 hours  
according to Maintenance Manual, item 10.4

Date of issue: August 26, 1991

This inspection program refers to airframes of the type H-36 Dimona only.

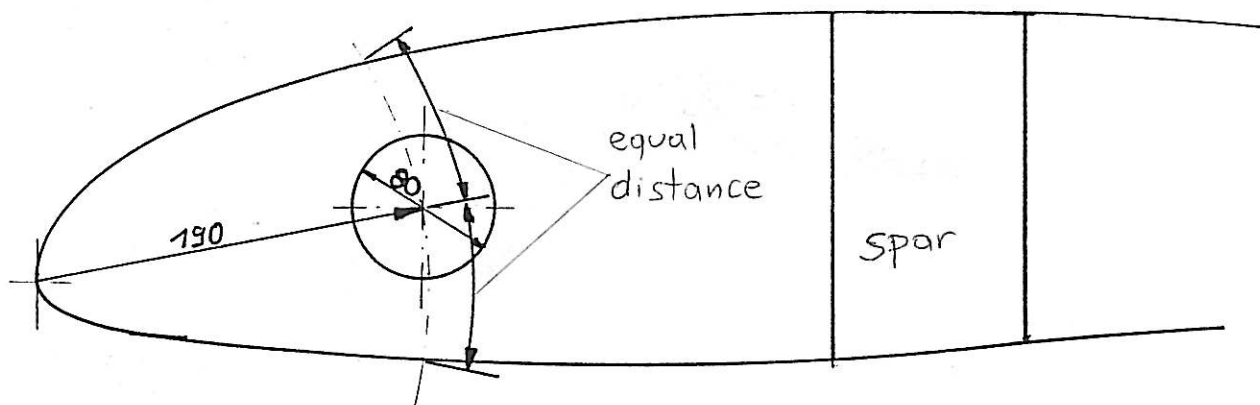
### 1. INSPECTION HOLE

Mark center 190 mm behind leading edge, exactly in the middle between upper and lower edge of root rib. Cut out inspection hole with 80 mm diameter (e.g. with rotating circular band saw). This hole need not be shut after the inspection.

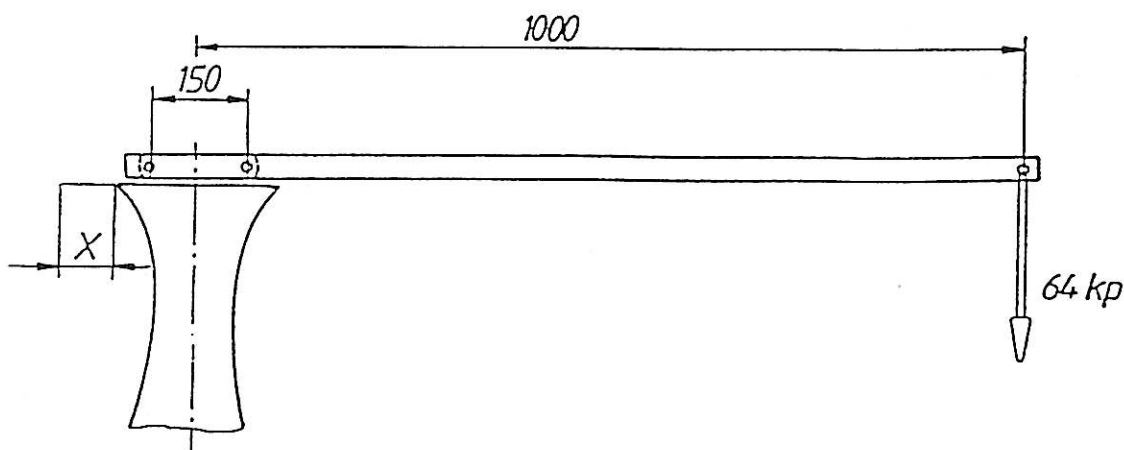
Deflection greater than 30 mm on one side - suspicion of damage to the structure in the region of junction of rudder unit and fuselage and the region of rudder unit arrangement.

Regardless of the measurement of the deflection, a visual check of the rudder unit, the fuselage tube, and all mounting parts in this area has to be carried out during the torsion test.

material: profile 40 \* 20 mm<sup>2</sup>  
length: 1200 mm

This instruction explains how to inspect the region of the junction of rudder unit and fuselage for damages due to overload.

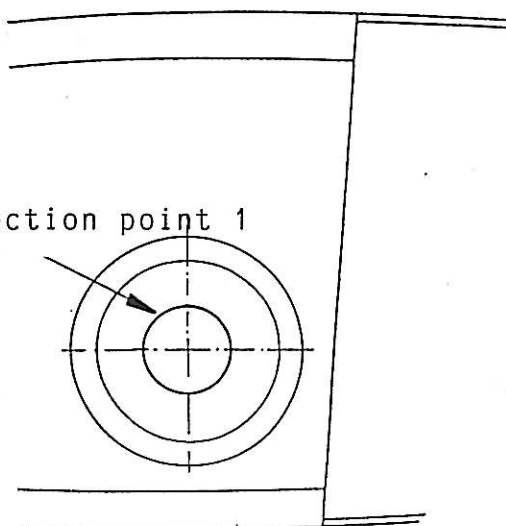
inspection point 1

- Remove paint and laminate around the bore for the A-bolt (50 mm) until the steel surface is uncovered. If corrosion is visible, continue uncovering the steel surface of the fitting until no more corrosion is visible.

- Remove corrosion with sanding paper.
- Cover inspection point with laminate as follows and paint it.  
6\*92125 layers, interglass quality finish I 550.
- In order to prevent further moisture from oozing in, seal gap between laminate and fitting with sealing agent PR 1005 L.
- Install A-bolt, secure with Loctite no. 648.
- Mount cross-screws of the fitting, seal with PR 1005 L.

The metal fittings of the A-bolts, which are laminated into the glass fiber reinforced plastic, have to be inspected for corrosion at two points.

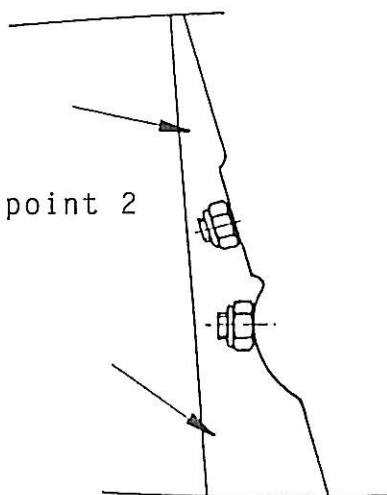
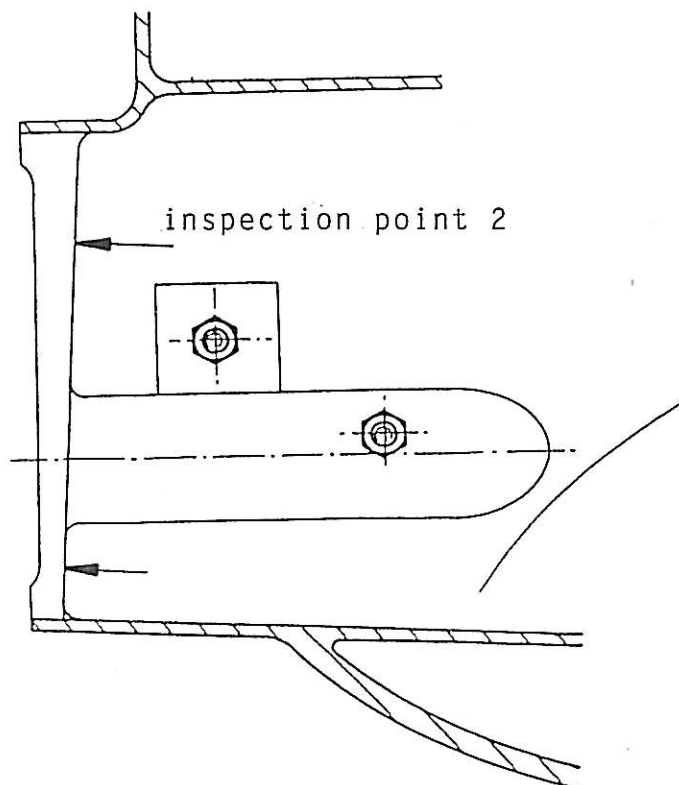
inspection point 2

- Uncover back side of the face of the A-fitting in the spar tunnel by removing the laminate. Starting at the rear edge, uncover the steel surface in steps of approximately 5 mm until no more corrosion is visible.
- Remove corrosion.
- Cover inspection point with laminate as follows:  
Paste one roving with at least 38400 tex, length 200 mm, along the rear inner edge of the uncovered fitting surface.  
5\*92125, interglass quality finish I 550. Make sure the repair layers cover the fitting entirely and seal it against moisture.
- Enter the result of the inspection in the Findings Report.

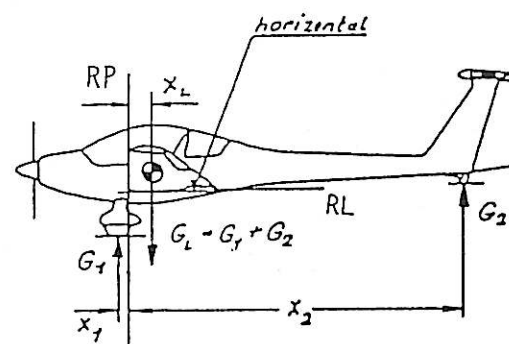
support	gross [kg]	tare [kg]	net [kg]	lever arm [mm]
front $G_1$				
rear $G_2$

$$x_{EH} = \frac{x_2 * G_2 - x_1 * G_1}{G_1 + G_2} =$$

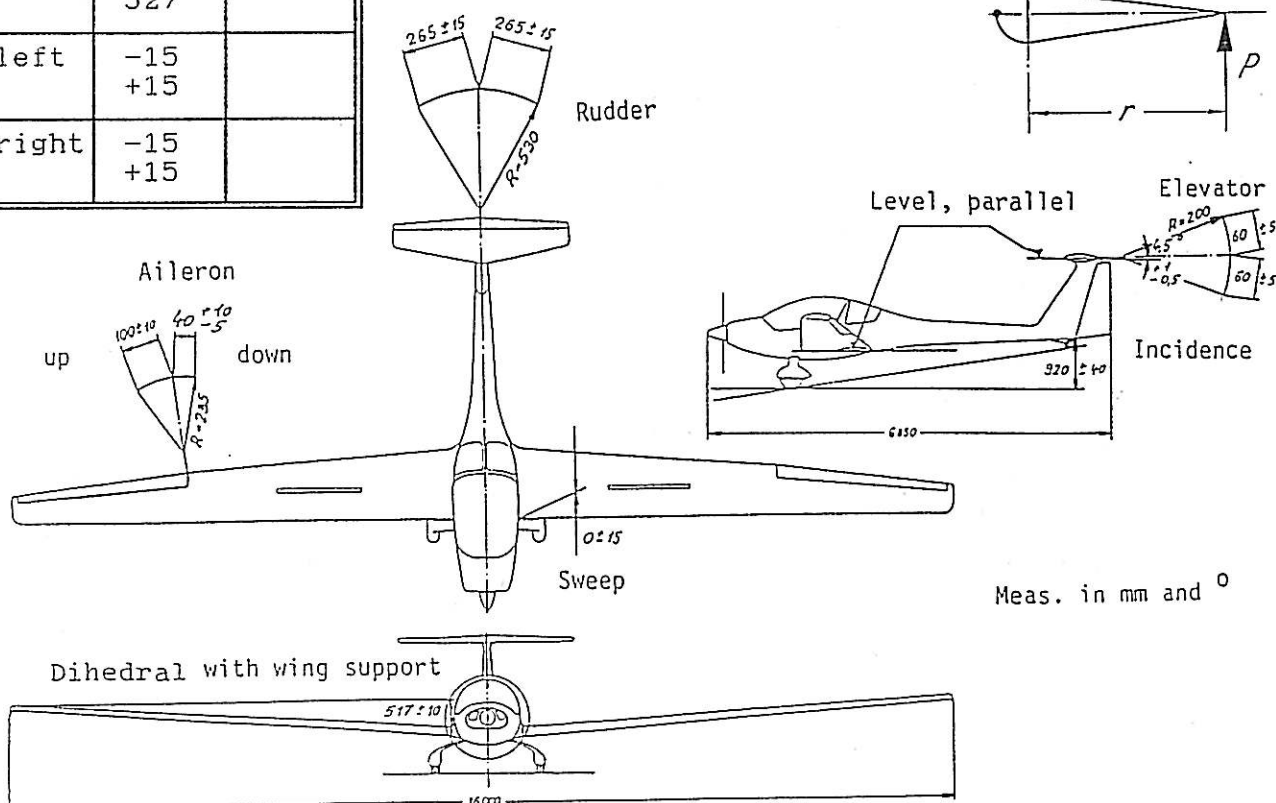
With the lever arm  $r$ , which is equal to the distance between the hinge line and the measuring point, the residual moment will be obtained:  $M = P \cdot r$   
with  $P$  in [kp],  $r$  in [cm] !

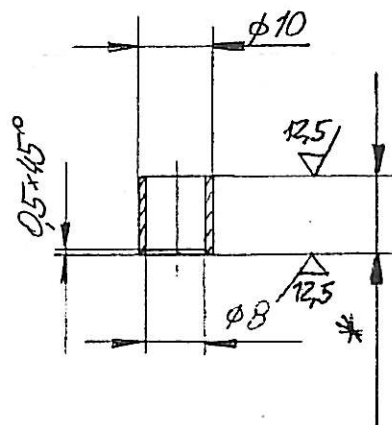
$\phi (12,5)$

\*: adjust during installation

1	2	Rohr	1.0308 / St35	$\phi 10 \times 1 \times (12)^*$
Pos.	Stk.	Benennung	Werkstoff	Abmessungen
			Freimaßtol.: m DIN 7168	Maßstab: 1:1
			1990	Dat.
			Bearb.	01-25
			Gepr.	07-29
			Normgep	
			Distance sleeve Distanzhülse	
			820-2730-02-08

- Work flow program
- Work order: root rib
- Work order: main bulkhead
- Work order: torsion test
- Work order: inspection of A-bolt fitting
- Findings report
- Weighing report
- Control surfaces adjustment report
- Drawing no. 01.1923.00 (rod end bearing)
- Drawing no. 820-2730-02-08 (distance sleeve)
- Clip of drawing no. 820-2730-02-00
